**GROUND DEFORMATION MONITORING BY CONVERGENCE
MEASUREMENT AND DAMAGED AREA MAPPING IN DEEP ORE
ZONE (DOZ) MINE AT PT. FREEPORT INDONESIA**

ANDRE SEBASTIANO GINTING and HADNALTIAS ALPEKI Underground
Geotechnical and Hydrology Department, PT Freeport Indonesia, Tembagapura,
Indonesia

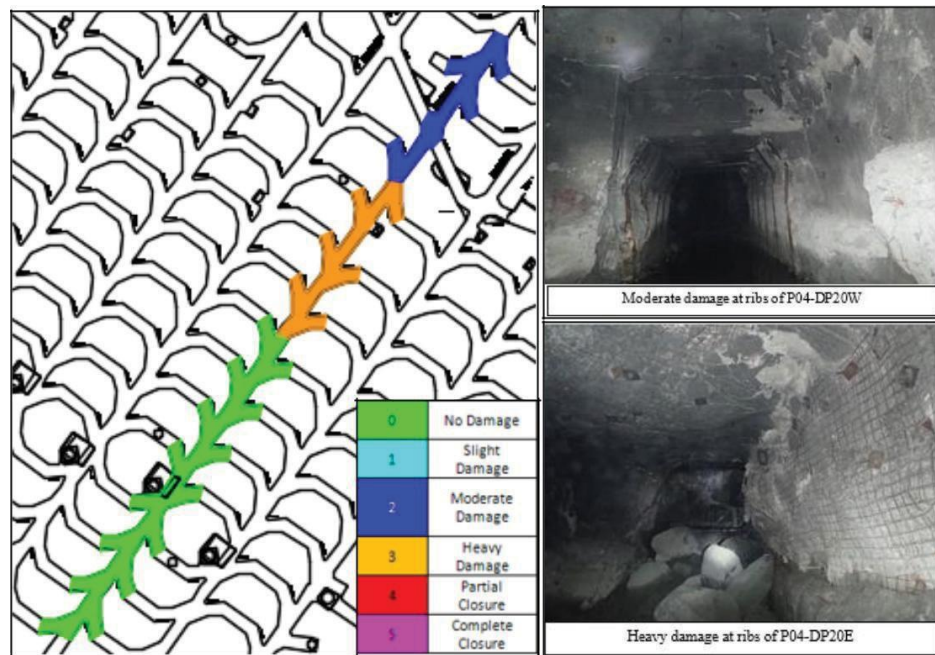
Figure 1. Damage Map of Panel 04 DP15E-DP20E

The moderate damage was observed at Panel 04 DP15E-DP17W, while the heavy damage was observed at Panel 04 DP18E-DP20E. The concern ground is located on heavy damage area, this area will be the first conducted rehabilitation.

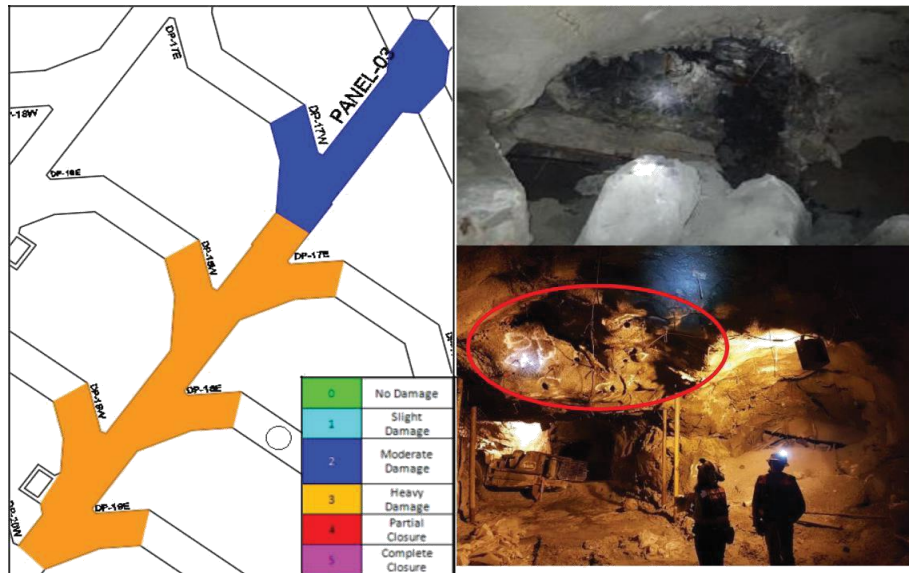
Figure 2. Damage Map of Panel 03

The moderate damage was observed at Panel 03 DP15E-DP17W, while the heavy damage was observed at Panel 04 DP17E-DP19E. The concern ground is located on heavy damage area, this area will be the first conducted rehabilitation. Steel probs also installed as ground movement indicator in front of DP19E

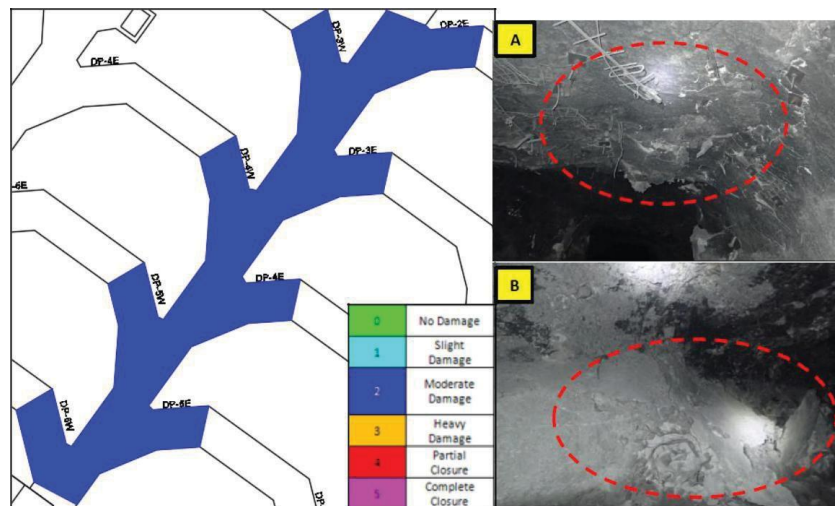
Figure 3. Damage Map of Panel 1H

The moderate damage was observed at Panel 1H DP02E-DP06W. The potential shotcrete fall has also observed in this area. Borehole camera and high pressure grout also conducted on this area related to reinforce ground support has been installed but the ground still barring down.

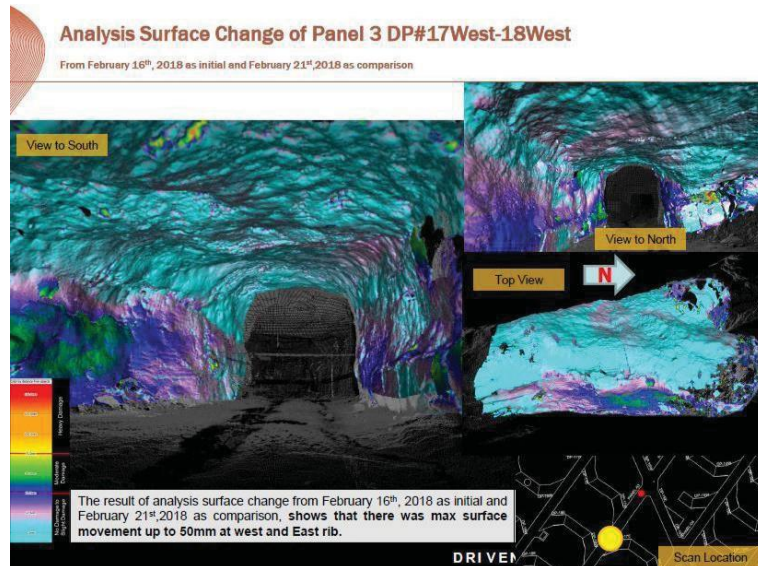
Figure 5. ZnF Scan Result of Panel 03

Based on ZF Laser Scan result on Panel 03 DP17W-DP18W, there was max surface movement up to 50 mm at west and east rib ground. It supports to convergence value recorded that there was a displacement in this area.

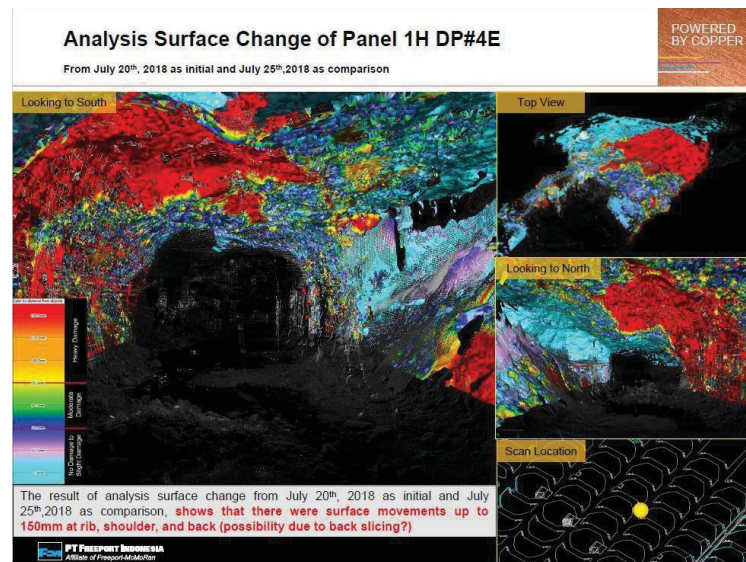
Figure 6. ZF Laser Scan Result of Panel 1H

Based on ZF Laser Scan result on Panel 1H DP02E-DP06W, there was max surface movement up to 50 mm at rib, shoulder, and back of ground. It supports to convergence value recorded that there was a displacement in this area.

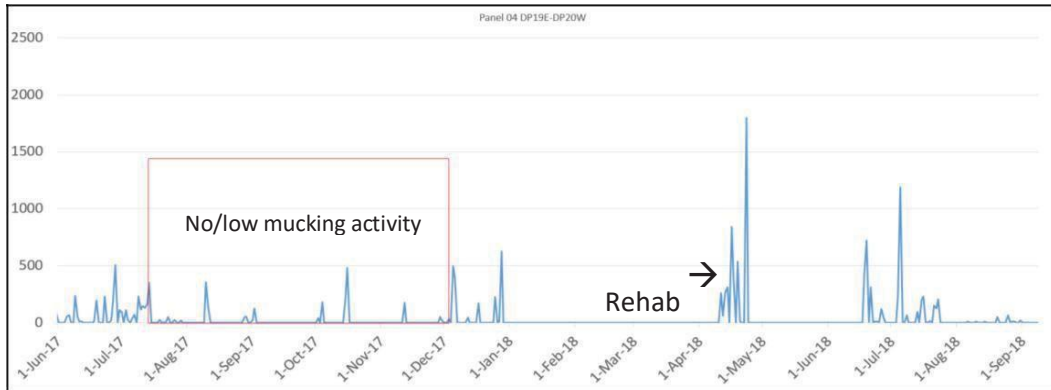
Graph 4. Mucking Activity at Panel 04

mostly caused static load which It has related to no mucking activity on the drawpoint. Based on mucking activity data and time of rehab, damage and significant displacement found after no mucking activity for long time, such as the graphs as below.
