**GROUND DEFORMATION MONITORING BY CONVERGENCE
MEASUREMENT AND DAMAGED AREA MAPPING IN DEEP ORE
ZONE (DOZ) MINE AT PT. FREEPORT INDONESIA**

ANDRE SEBASTIANO GINTING and HADNALTIAS ALPEKI Underground
Geotechnical and Hydrology Department, PT Freeport Indonesia, Tembagapura,
Indonesia

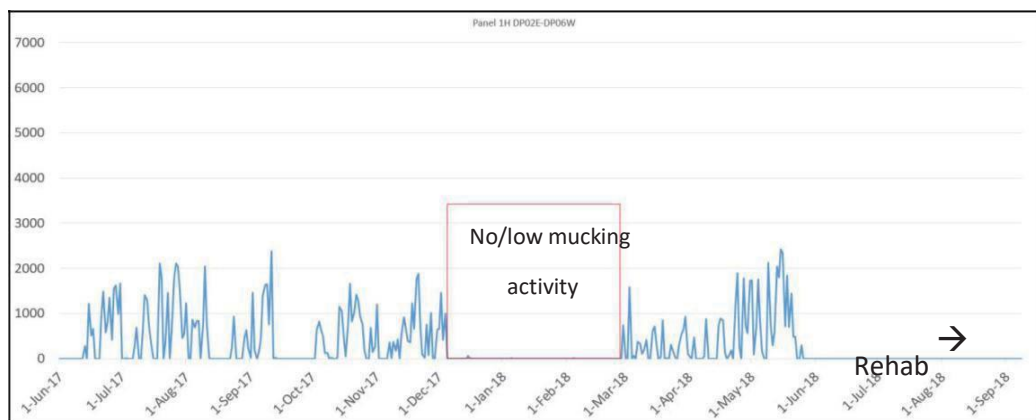
mostly caused static load which It has related to no mucking activity on the drawpoint. Based on mucking activity data and time of rehab, damage and significant displacement found after no mucking activity for long time, such as the graphs as below.

1. Ground always searches for stable condition when there is excavation. No mucking activity on a drawpoint will be static load/stress to the drawpoint. Uniform mucking activity is the better way to reducing potential damage occurred on pillar.
2. PT. Freeport Indonesia still keep safety as first value beasuce PTFI have responsibility for all the underground employee. “If there is no monitoring, then there is no mining”
